Experimental Study ND 98-01

**Evaluation of Portland Cement Concrete
as a Rehabilitation Option for
Overlaying an Existing Asphalt Roadway**

Second Evaluation Report

Project NH-2-052(012)244

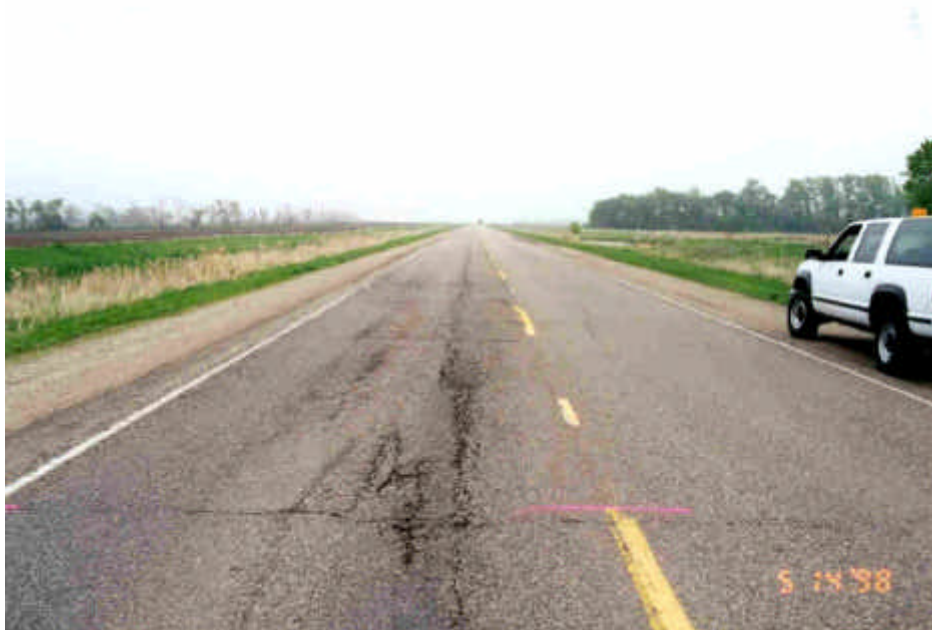
The roadway in question was experiencing distresses such as longitudinal and transverse cracking, rutting (1/8" to 3/8") and shoving pavement, and depressed transverse cracks. This segment of roadway was listed as poor for the ride and the international roughness index. Photo 1 depicts an overview of a segment of US 52 and a close-up of a depressed crack area. One of the rehabilitation options of this roadway was to mill the existing asphalt and overlay with new HBP. However, this option was not considered since the existing cracks would inevitably reflect through the new pavement.

Photo 1 - Overview of distressed areas on a segment of US 52.

The longitudinal cracking in test sections 1 and 3 are likely the result of poor subgrade conditions. The location of the longitudinal cracks is in the same area as the distresses shown in photo 1 prior to whitetopping the asphalt. These distresses appeared to have reflected through the whitetopping sections.

The option of mining and blending the existing asphalt and base together and overlaying with HBP was chosen. The proposed asphalt rehabilitation was to mill and remove 9" of asphalt. Aggregate was placed on the remaining roadway structure and blended together to achieve a 14" base. A 5" layer of HBP was placed on the blended base section.

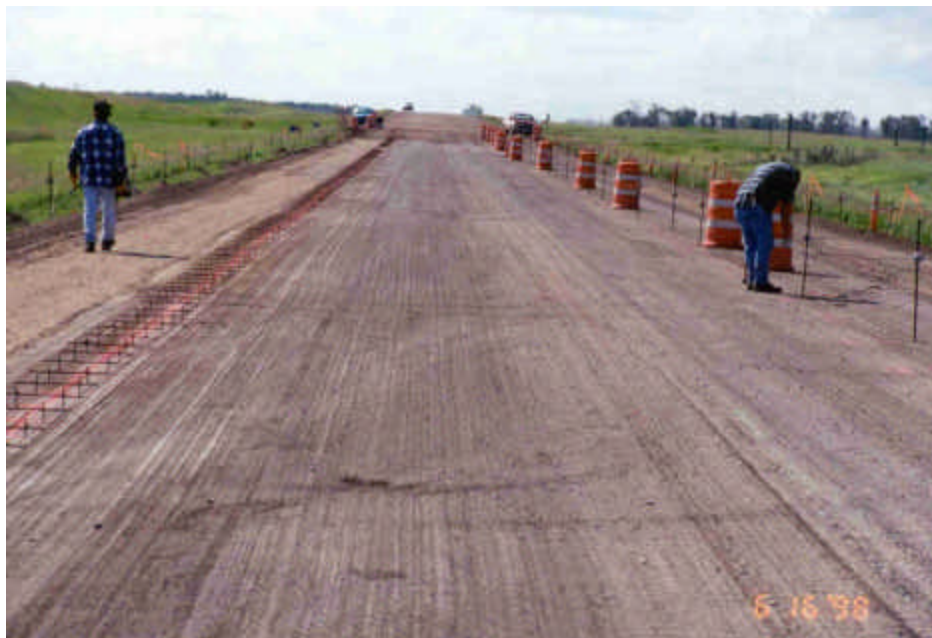
Photo 2 depicts the surface after the milling was concluded. Upon further examination there appeared to be some loose particles and dust still present on the surface. On the left side of Photo 2 tie bars are visible which are located between the impending shoulder and mainline.

Photo 2 - HBP surface after milling was concluded.

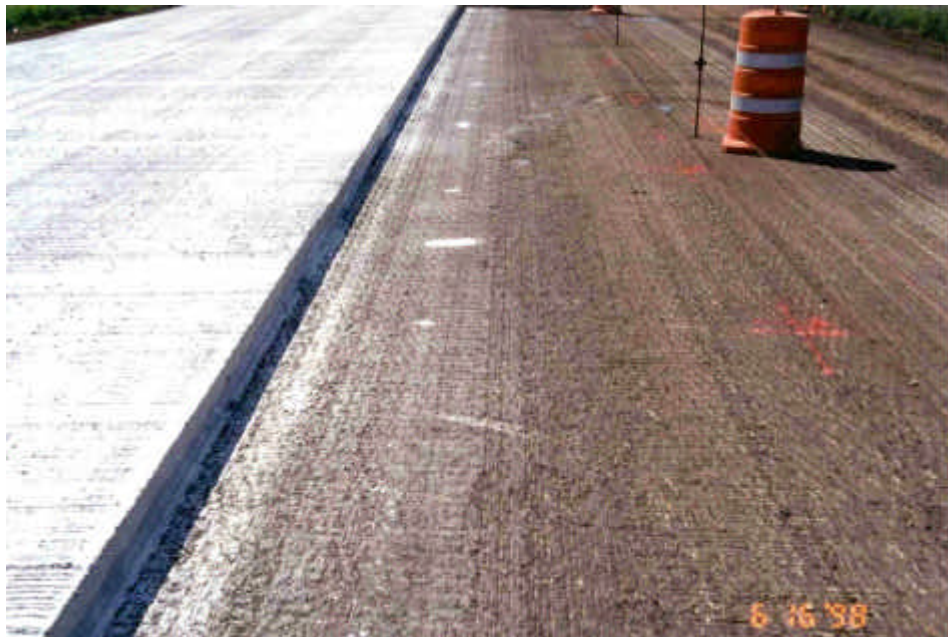
Photo 4 - View of excess curing compound sprayed where the southbound lane would be constructed.

The NDDOT personnel were concerned the over-sprayed curing compound would hamper the bonding effect between the PCC and the existing asphalt. The contractor agreed to remove the compound from the surface prior to placing the slab. The contractor finished all three test sections in the northbound lane by mid to late afternoon. Although precise times were not kept, the placing of the 6" slab required a little more time than the 5" slab because of the increase in the volume of PCC. The contractor commented that the job would have progressed at a faster rate if the ready mix trucks could have kept up to the paver.

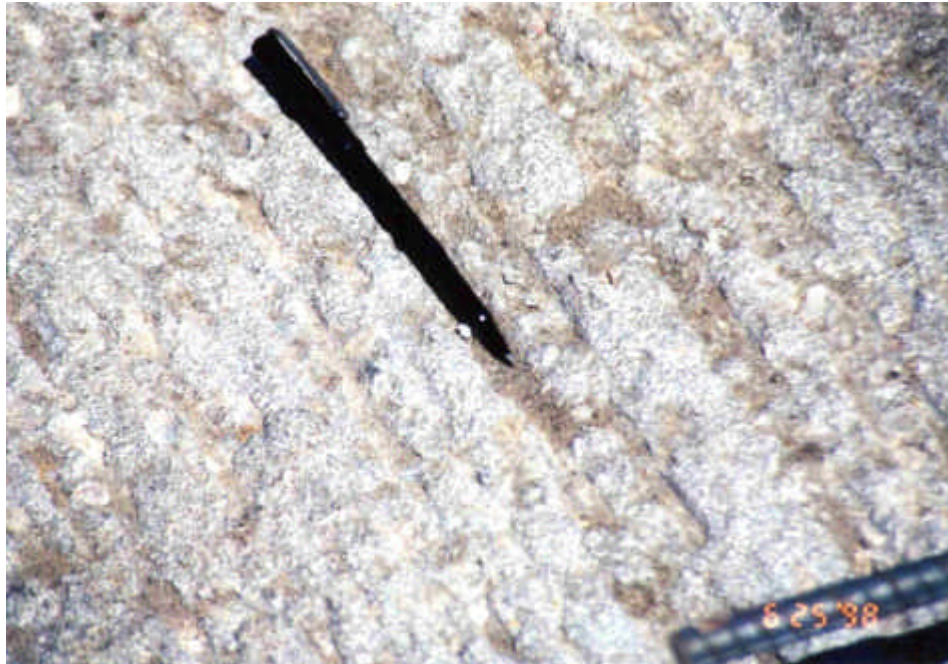
Photo 6 shows a close-up view of small particles and dust that remained on the milled surface and were not blown off prior to paving.

Photo 6 - Small particles found on the HBP prior to being blown off.

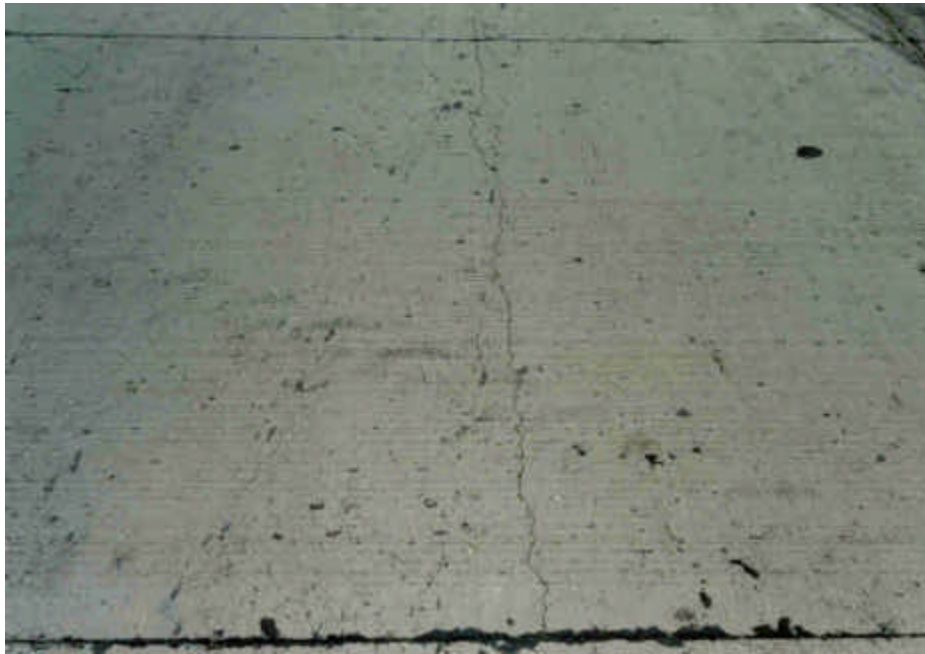
Photo 7 depicts an overall view of test section 1. A representative of the Materials and Research Division visited the site a few weeks after construction. The test sections were free of distresses except for a longitudinal crack located in the northbound lane near the beginning of test section 1. Photo 8 depicts a view of this distress which spans approximately 40'.

Photo 8 - Longitudinal crack in test section 1 after construction.

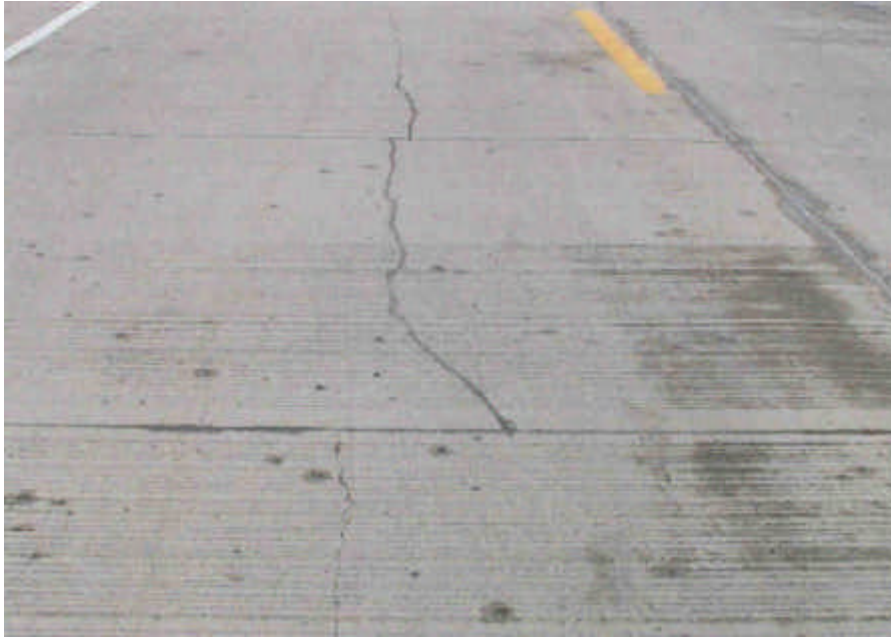
During a post construction evaluation of section 1, it was discovered that some cracks had begun to form. In the summer of 1999 the Valley City district performed some preventative maintenance on the longitudinal cracks. This process consisted of sawing out $\frac{1}{2}$ " of PCC around the cracks and filling with the polymer sealant CRAFCO 231. Photo 10 taken in 2001 shows one of the repaired cracks.

Photo 10 - Repaired longitudinal crack.

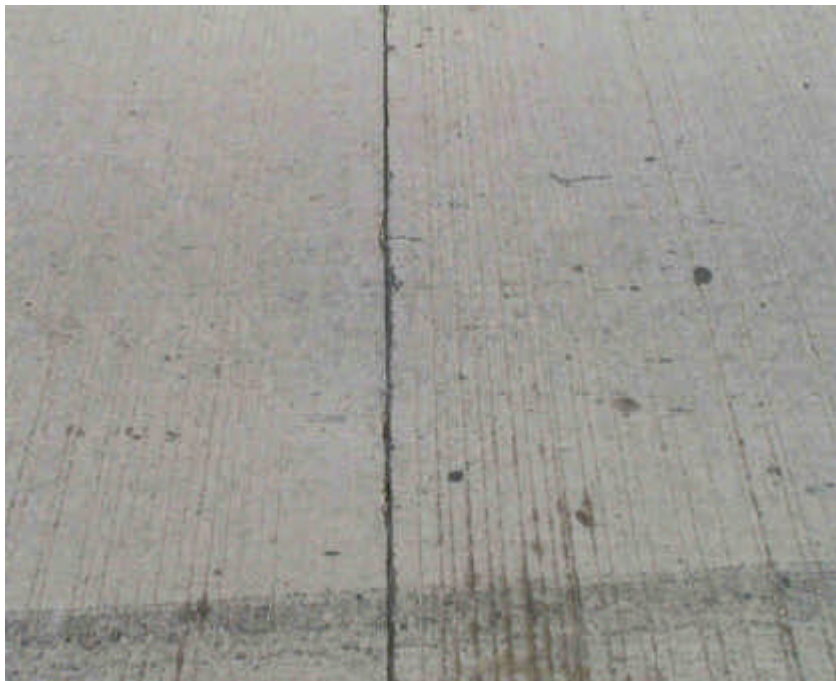
The review team located approximately 140 ft of low severity longitudinal cracking that occurred in Section 1. One corner break was also noticed. Some spalling was occurring at approximately every other transverse joint. The sealant was losing contact with portions of the PCC panels due to spalling. Photo 11 shows the condition of a typical joint and areas of low severity spalling.

Photo 11 - Typical transverse crack.

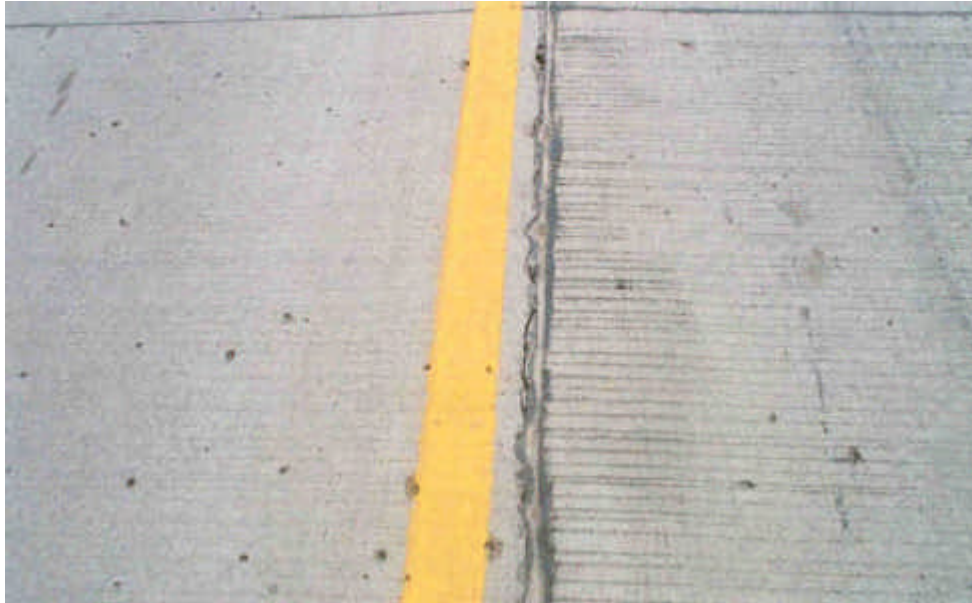
The centerline joints also showed signs of distress with low severity spalling and some sealant damage. Photo 12 illustrates one of the more severe distress areas along the centerline joint.

Photo 12 - Longitudinal joint spalling and adhesion failure in the sealant.

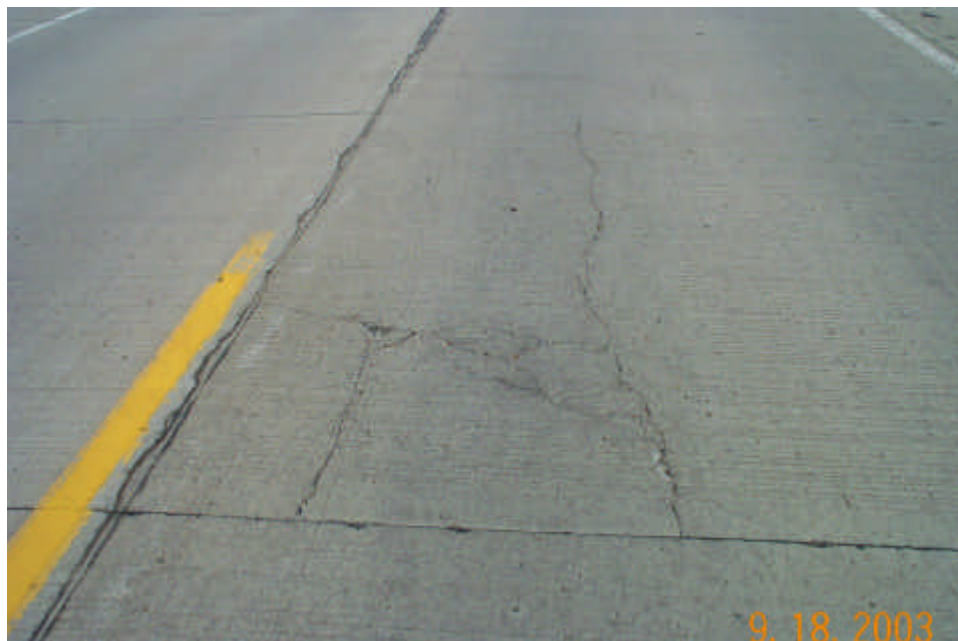
There is one area that is starting to block crack, which indicates a possible subgrade problem.

Photo 13 - Block cracking starting to occur in section 1.

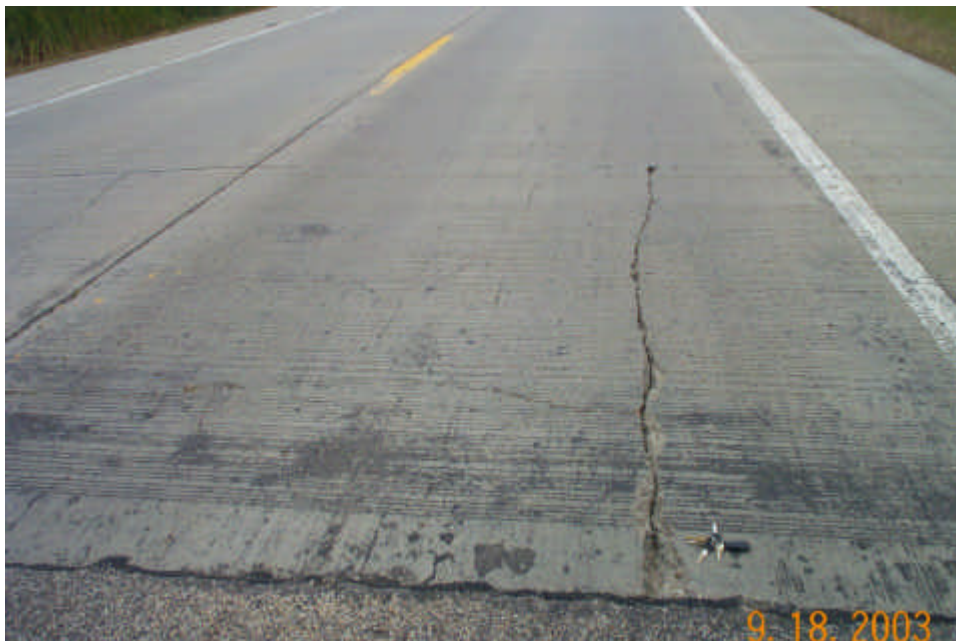
The review team located approximately 104 feet of low severity longitudinal cracking that occurred in Section 3.

Photo 16 - Longitudinal crack adjacent to control section looking north.

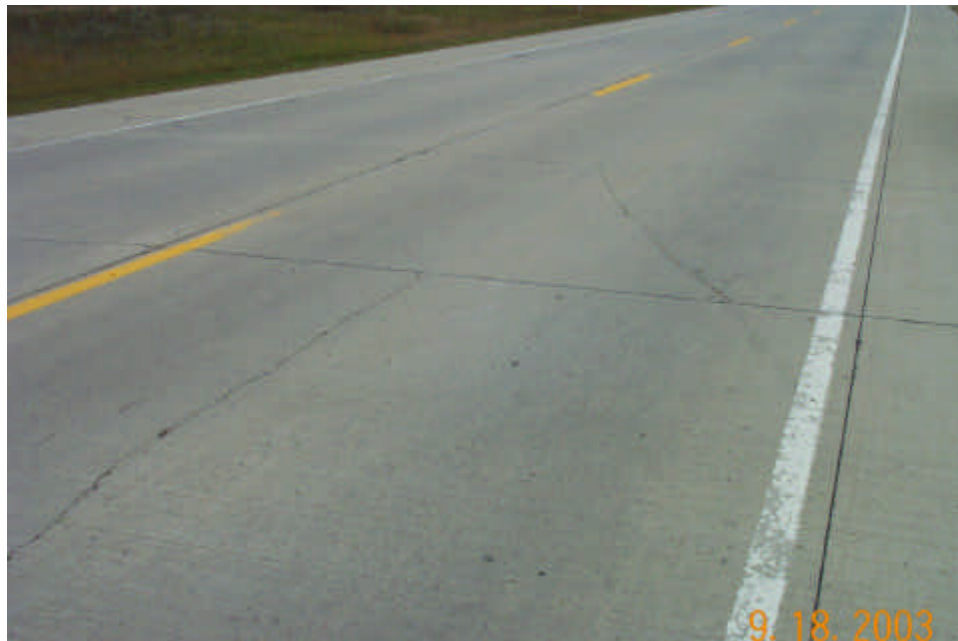
There were also four corner breaks in this section which still appeared to be very tight.

Photo 17 - Test section 3 corner break and longitudinal crack.

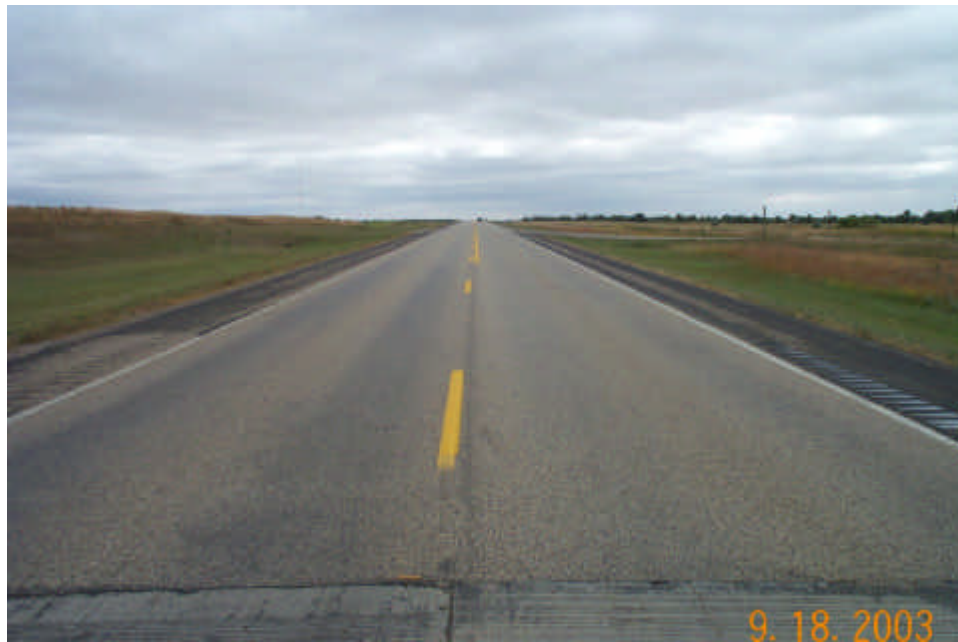
The review team also inspected the asphalt control section located directly south of the whitetopping test site. The section appeared to be in good condition. Photo 18 shows the general condition of the control section. Some bleeding had occurred in the north bound lane.

Photo 18 - Overview of control section looking south.
